Report on the Structure and General Condition of:
23 Adelphi Street, Campbell Park, Milton Keynes, MK9 4AE

Inspected 19th July 2010

**Report on the Structure and General Condition of
23 Adelphi Street, Campbell Park, Milton Keynes, MK9 4AE**

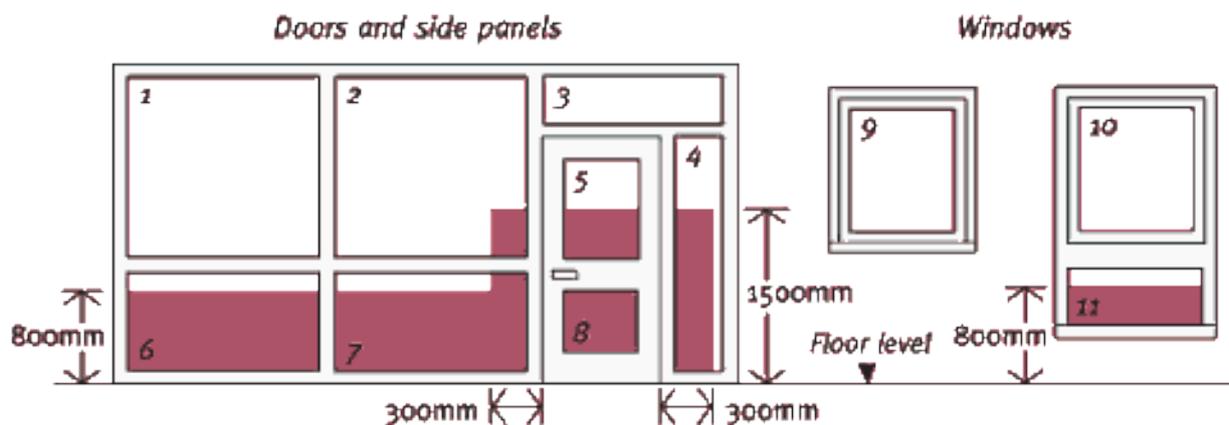
A diagram showing the position for safety glass required by the Building Regulations is given below.

Accidents involving glazing as indicated can have serious consequences. Replacement of glazing, the use of internal barring or the use of protective laminate films is advised.
