# INFORM

INFORMATION FOR HISTORIC BUILDING OWNERS

## Damp Causes and Solutions

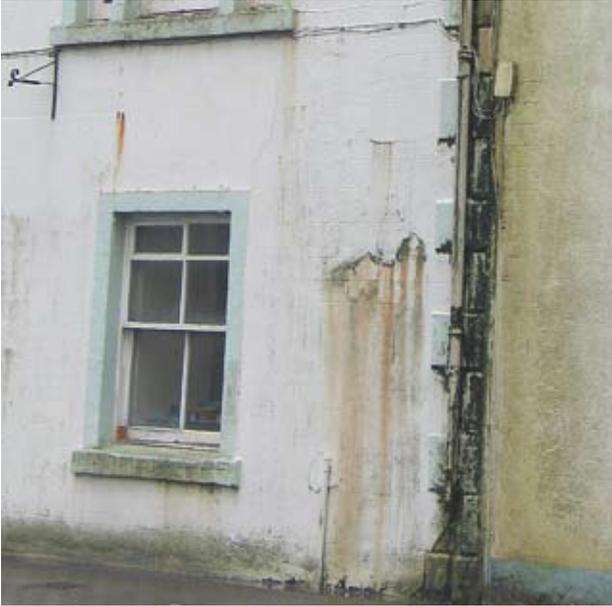
*Blocked downpipes causing staining and failure of render*

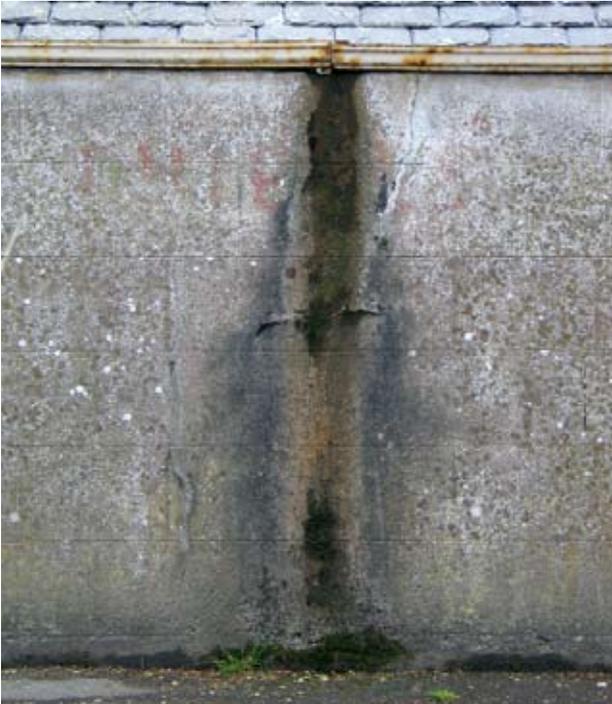
*A leaking gutter saturating a wall*

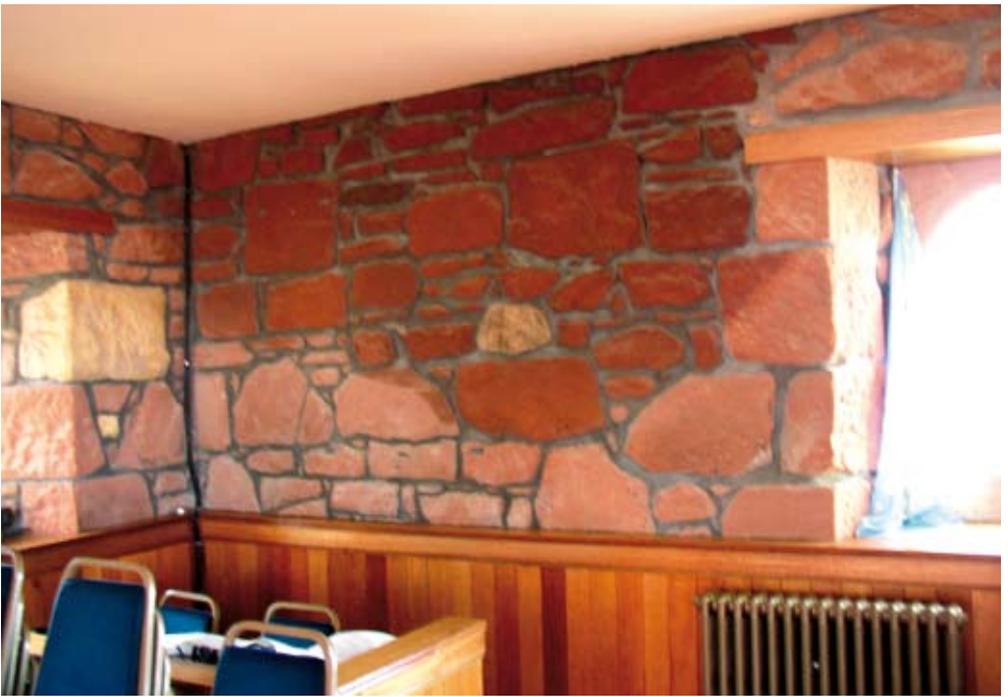
*A masonry wall saturated from leaking element above.*

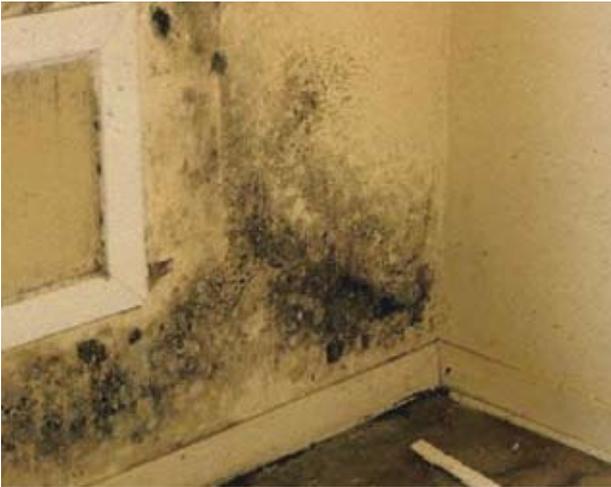
*Mould growth from condensation on the cold part of a lined wall*

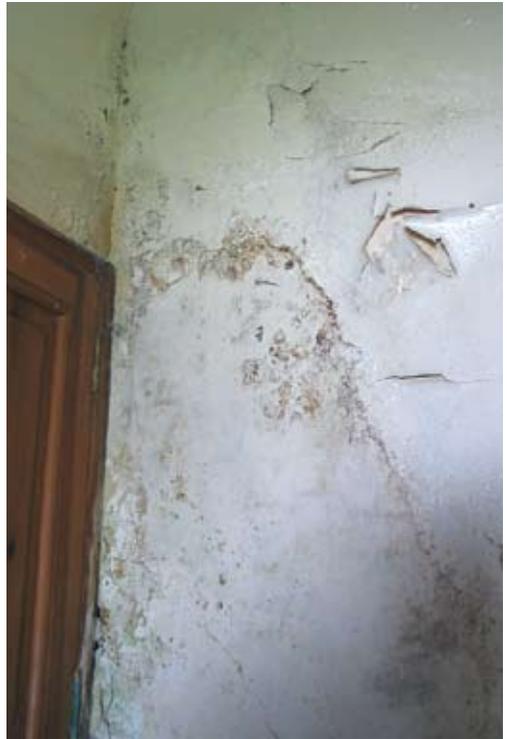
*Blistering and peeling of a non-permeable paint*

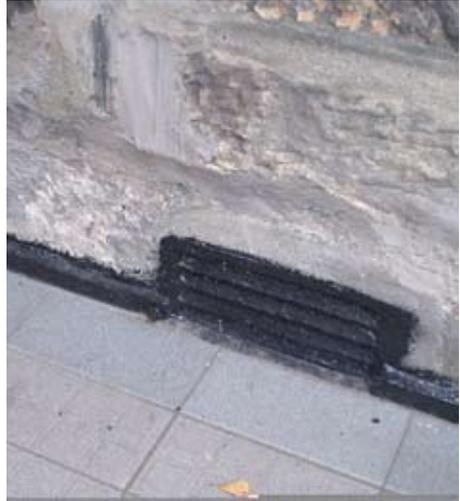
*Partially obscured vent inhibiting ventilation and tiling concentrating moisture.*

of any applied insulation. Do not block or remove vents. The area below floor joists should also be kept clear to avoid moisture transfer, and the ground level outside set approx 150 mm below this level.

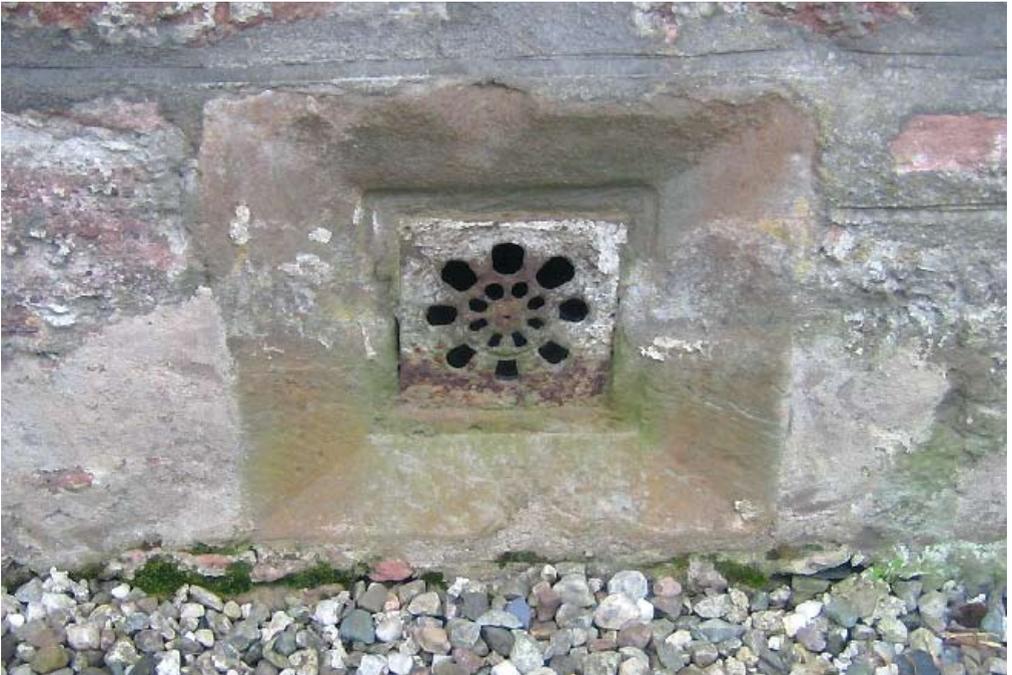
*A solum vent at the correct height. Note the staining from previous raised ground level.*
