# INFORM

INFORMATION FOR HISTORIC BUILDING OWNERS

## Indent Repairs to Sandstone Ashlar Masonry

This INFORM provides an introduction to the practice of replacing damaged stones in an ashlar built sandstone wall. Referred to as indenting, the technique involves replacing badly decayed or damaged blocks with stones of similar dimension and physical characteristics.

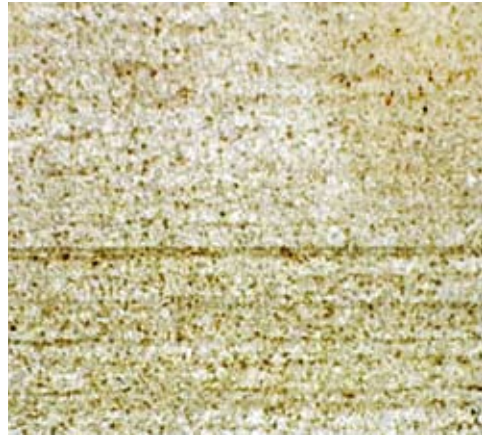
In creating an ashlar build stonemasons were guided by observing the natural qualities of the stones they were using. The identification and alignment of the stones' bedding plane - the way in which the loose sand grains were laid down in geological times before the stone was properly formed - needed to be properly understood. Sandstones' inherent strength comes from this feature and the various minerals that, geologically, bound the individual grains of sand together.

As the natural bedding planes normally lay horizontally, individual sedimentary stones, such as sandstone, were similarly aligned by the masons with their natural bedding planes set horizontally. This offered their buildings considerable structural strength.

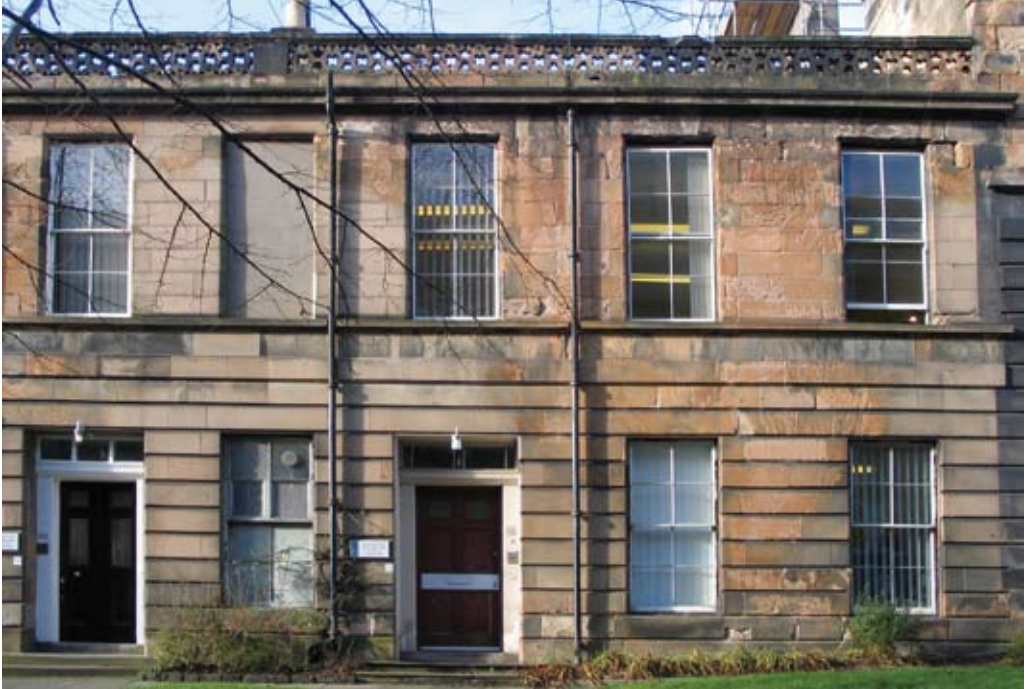
When nature was ignored, the performance of sandstone was less effective. This is particularly found where ashlar block walls were built “on cant”, with the geological bedding set vertically, rather than horizontally. When “face bedded” in this way the stone’s strength is not used to advantage, and the outer faces of the stones become prone to failure through a process know

as delamination. This effect can trigger the need for a considerable degree of indent work, as the characteristic failure of the bedding planes can lead to the complete loss of the exposed face across a building's elevation. Fortunately, it is more usual to find buildings constructed in the appropriate manner, with only a few individual stone blocks ever requiring attention.

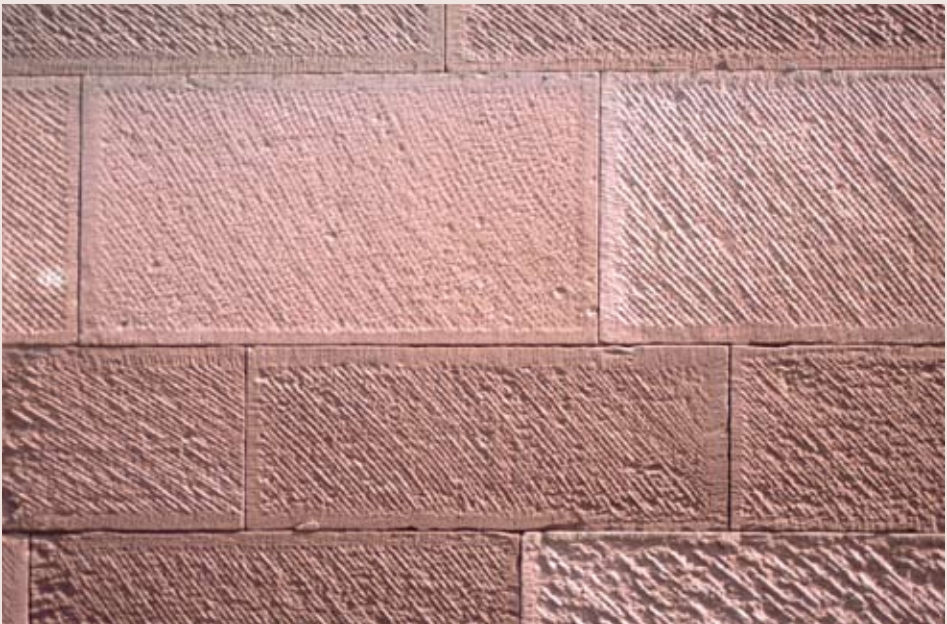
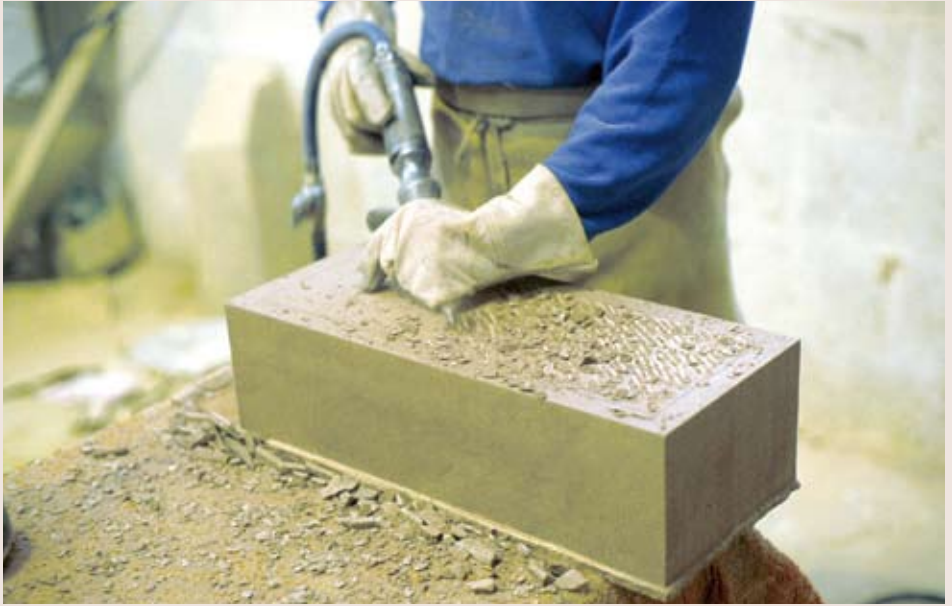
As original ashlar build “stagger” the alignment of the vertical joints between the blocks in different courses, it is good practice to maintain this original pattern of building when indenting more than one stone. In doing so, the structural strength of the wall is maintained.
