HISTORIC SCOTLAND

INFORM

INFORMATION FOR HISTORIC BUILDING OWNERS

Domestic Chimneys & Flues

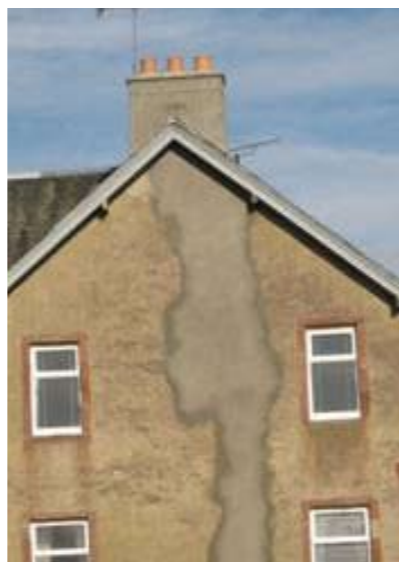
A flue relined from the outside.

- Fitting of ceramic flue liners. This is arguably the better long term solution, as it addresses the internal structure of the flue. However, it tends to reduce the bore of the flue so ensure a size of liner is commensurate with the type of fire or appliance to be used. Holes are made in the wall every 1.5 m or so, and a ceramic liner is inserted and bedded in a weak lime mortar. This process is continued up the wall until the chimney is reached. The process is disruptive, although if the flue can be accessed from the outside this is reduced, but with the consequent need for scaffold. It is also possible to rebuild the flue in the original manner, with stone bridges and slab lining, although this is more time consuming and thus expensive.

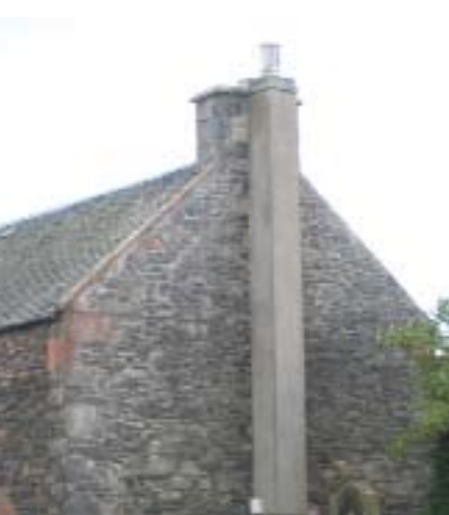
A new flue on the outside face of the gable

In the past an additional chimney flue and stack was often built adjacent to the gable. This is not an acceptable solution, as it spoils the appearance of the elevation.

Single or multiple flues were normally built into the thickness of a masonry wall, frequently on the gable ends. In larger properties with internal masonry walls, flues were run up through internal walls. In cases where there have been flue problems, or a hearth was added, flues have been added against a gable, sometimes externally or internally. The shape of the flue is normally a square or a rectangle, earlier flues from the 16th C tended to be much flatter rectangles, reflected in the shape of the chimney head.

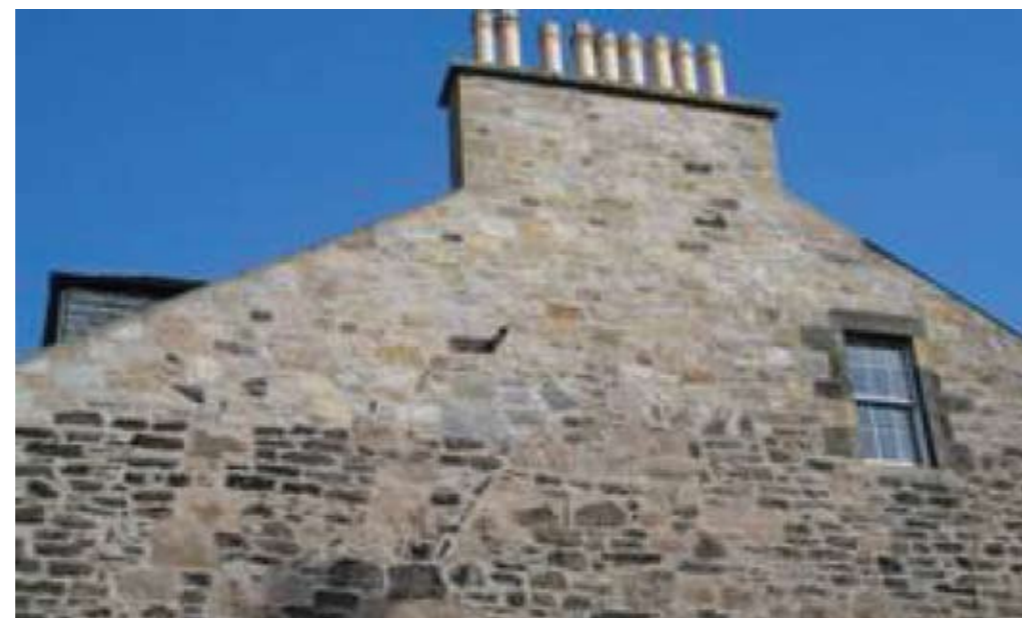
Stone bridges visible on the gable of this tenement in Edinburgh.

(a layer of lime mortar sometimes called pargetting). As fuels have become more energy intensive, flues have tended to become smaller and more effectively lined. Where the builders had to fit a large number of flues within a gable, such as a tenement, stone slabs were used to separate flues. The pattern of these slabs can sometimes be seen on gable ends of tenements. Later in the 19th C, ceramic flue liners were used, as well as being quicker to fit and build, they have also proved more durable, as they seem better able to resist corrosive flue deposits.

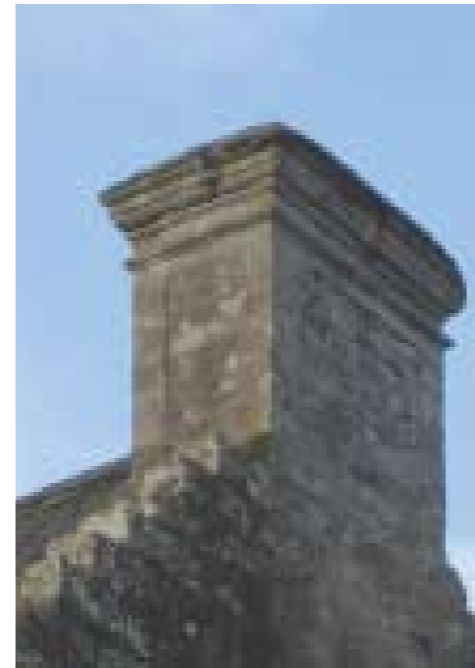
Banding on this late 17th C chimney.

strength. If the cope is being replaced it should be done in stone, with the correct drip detailing on the underside to ensure water is shed clear. Many traditional buildings have a string course or band of projecting masonry that throws water clear of the gable.

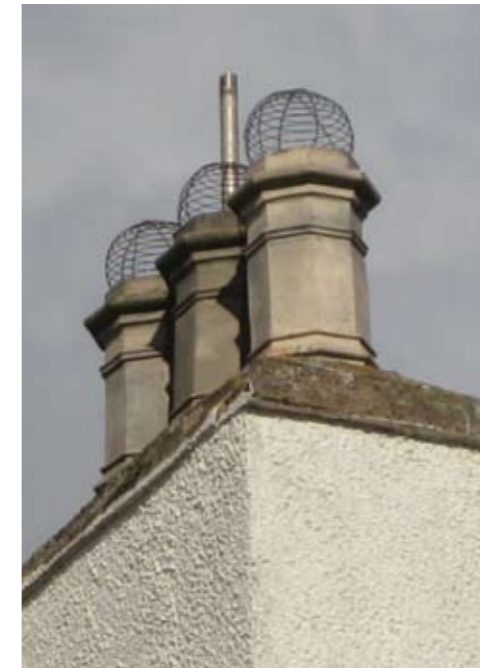
19th C Cans with bird grilles.

Up until the late 18th C, chimney heads were finished with a cope only, but from the 19th C all but the largest chimneys were finished with clay pots or cans. They developed in many styles, with some 19th C ones being very decorative indeed. The pot is sometimes set into a slight recess in the cope, and mortared in or “haunched” with mortar.

Chimney Cans. Over time, the haunching washes out or becomes cracked, and the chimney pots, or cans become loose. This will require re-bedding in fresh mortar. Occasionally the can itself becomes cracked and broken and they should be replaced. Invariably styles are limited, but cans should be matched where possible - in height and colour as a minimum. If the fire is not used the can should be covered, preferably with a conical galvanised cover fitted with bird netting. Ceramic covers are available, but do limit ventilation somewhat. If there is evidence of damp in the chimney they should not be used.

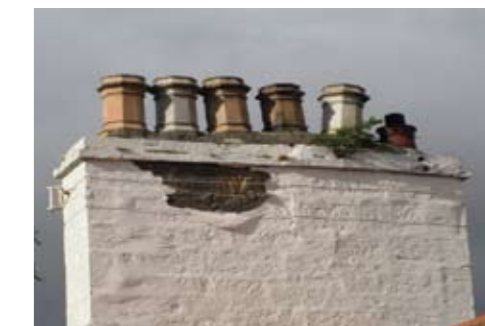
A mid 19th C chimney and cans showing a variety of problems.
