INFORMATION FOR HISTORIC BUILDING OWNERS

Pantiles Maintaining a Pantiled Roof

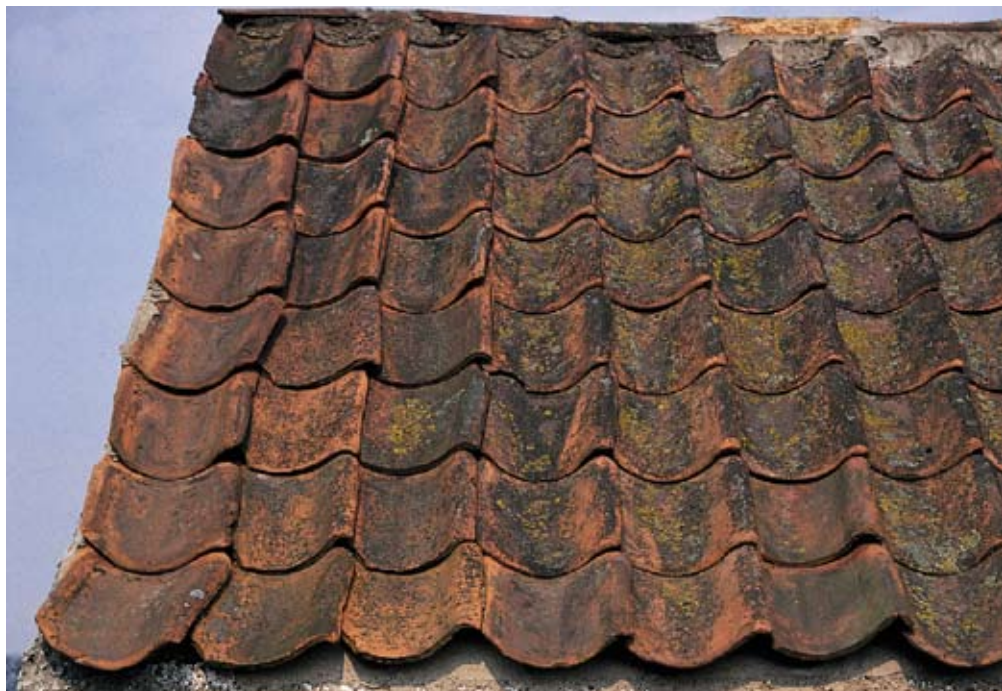
An exposed roof showing battens onto which pantiles are hung by their nibs

A pantiled roof has a series of regularly spaced horizontal battens attached to the rafters on which the tiles are hung. The tiles have a projecting nib on the back. This small projection on the rear of the tile holds it in position when laid on the batten. The battens needed to be spaced evenly to ensure the tiles maintained the appropriate lap over their underlying neighbour.
