**INFORM**  
 INFORMATION FOR TRADITIONAL BUILDING OWNERS

# Structural Joinery

**Structural joinery elements make up some of the key parts of a traditional building and their correct function is of crucial importance. Structural joinery refers to the timbers which form the roof and floor construction, and this INFORM will cover the survey, inspection and repair options and principles associated with work on these elements of a traditionally built property.**

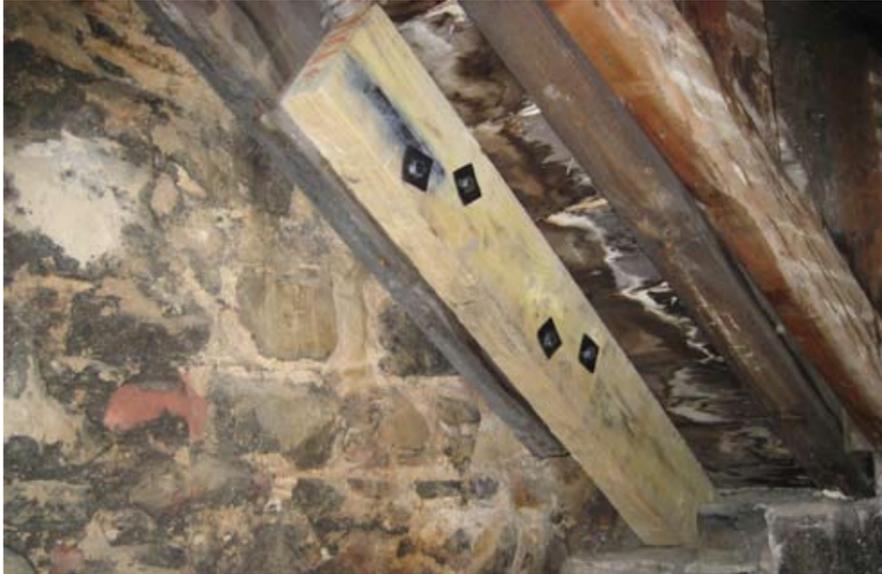
*Strengthening of the joint with bolts*

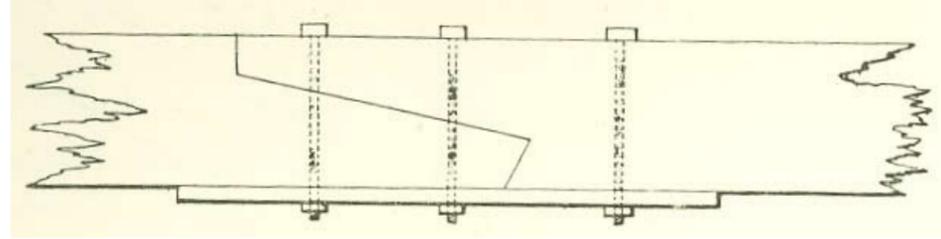
*19 C illustration - Joining of timbers, with iron plate and bolts for additional strength*

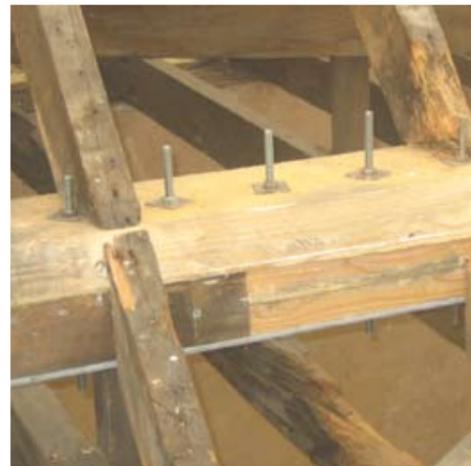
*Composite repair using resin, new timber and steel plate*

Resins and glues. Some engineers specify an epoxy resin to be used in structural repairs, especially in areas where the thrust is in more than one plane of the timber element (for

example valley beams). Such resin is normally a slow setting resin, giving time for the resin to soak into the matrix and fibres of the timber.

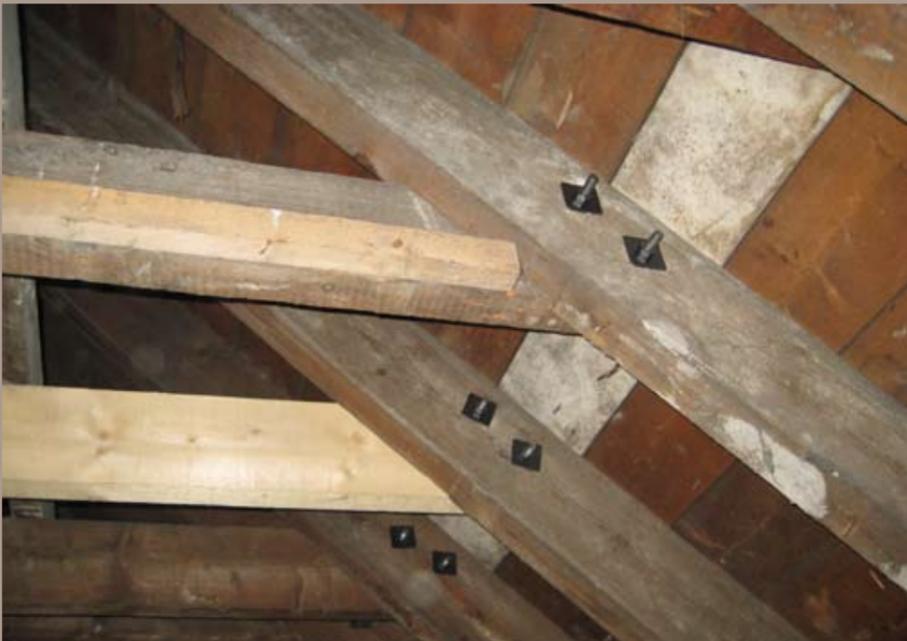
*Strengthening of the joint with bolts*

Areas of sound timber can become less stable by the loosening or failure of the iron nails, common at tie beams and the apex joint. Where possible the old nail should be removed if it has failed, and a stainless steel bolt and washer set fitted, remembering that old nails can assist in dating the building. Normally one bolt is sufficient for stiffening.

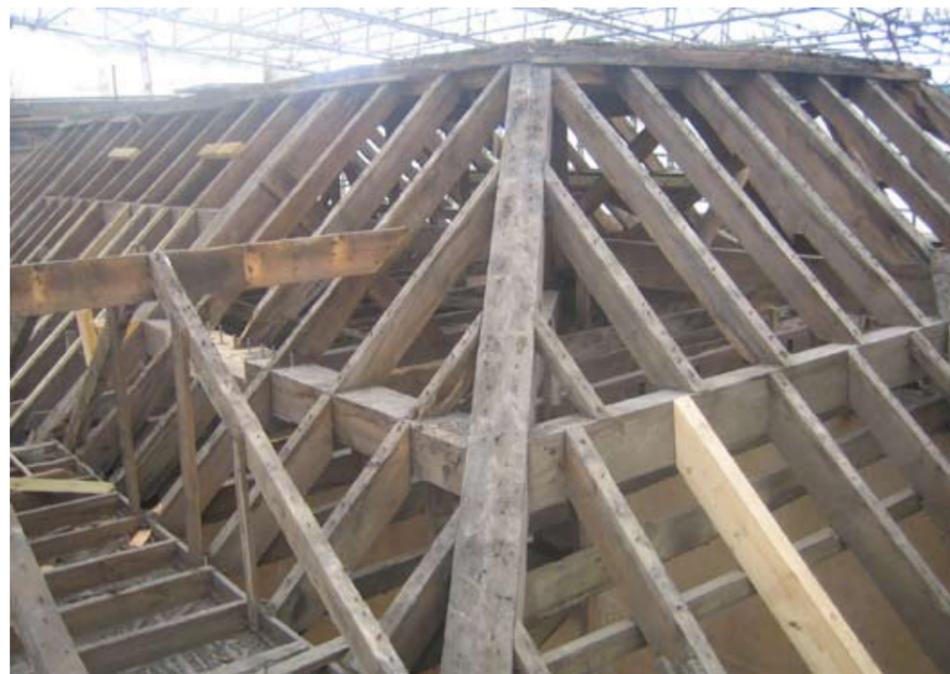
*A roof of the Late 18th under repair, showing the purlins midway in the span.*

In some earlier roofs, the A-frames are fewer, and joined longitudinally by timbers called purlins, shorter and smaller rafters then carry the roof. As the rafters have to carry more weight, they are referred to as principal rafters. This type of roof became rare by the 19th C, and standard A frame

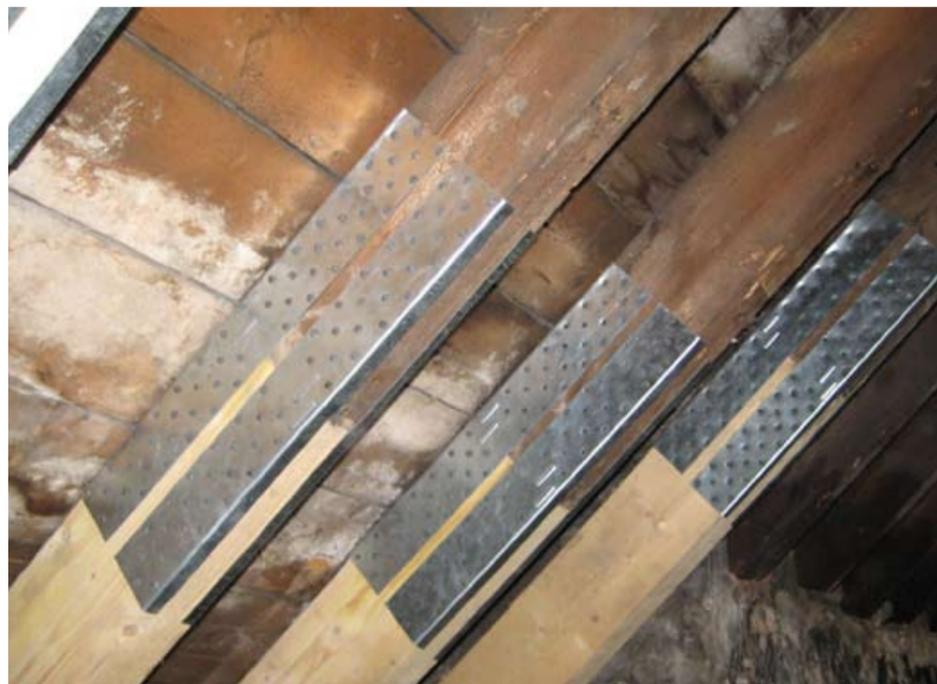
*Modern metal pre drilled straps used in rafter splices.*

Plating using modern steel is a similar approach, but using preformed steel plates, angled to fit the joist. They are fixed with ringshank nails. This repair is simple and

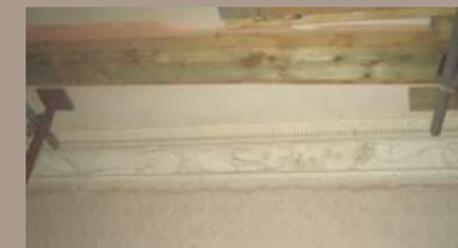
*Supporting a ceiling during work on the joist ends*
