Principal author: Ingval Maxwell
Published by Technical Conservation, Research and Education Group, May 2008
Historic Scotland, Longmore House, Salisbury Place, Edinburgh EH91SH
Tel: 0131 668 8638 Fax: 0131 668 8669
www.historic-scotland.gov.uk email: hs.conservation.bureau@scotland.gsi.gov.uk
All photos by Ingval Maxwell

Domestic Boundary Walls

INFORMATION FOR HISTORIC BUILDING OWNERS

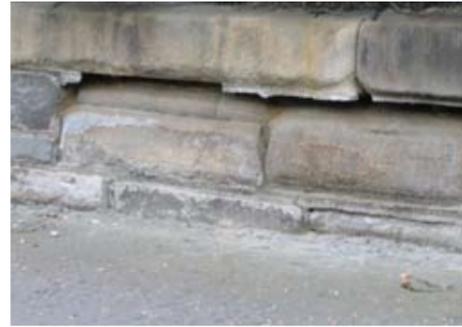
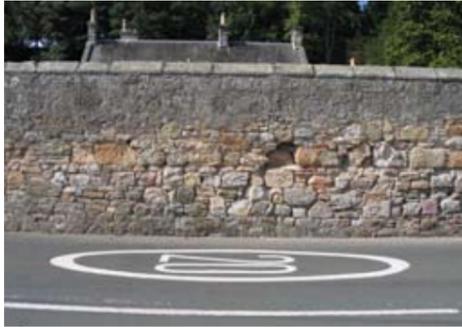
Wall foot damage

Another area where boundary walls are vulnerable to decay is in the vicinity of the wall footings - especially where there is a risk of salt being laid on adjacent roads and pavements during winter months. In these circumstances, the salt can be regularly splashed onto the stonework and this can lead to a significant breakdown of the mortar and the stone.

In recognising that it is difficult to avoid circumstances where walls are adjacent to surfaces that are routinely treated with winter salt, repairs should be carried out to both stone and joint work whenever signs of degradation are noted. If left unattended, the salt contamination can continue to decay the masonry to such an extent that it can undermine the structural stability of the wall, leading to its eventual collapse. In some cases this will mean replacing badly eroded stones to stop the process getting worse.

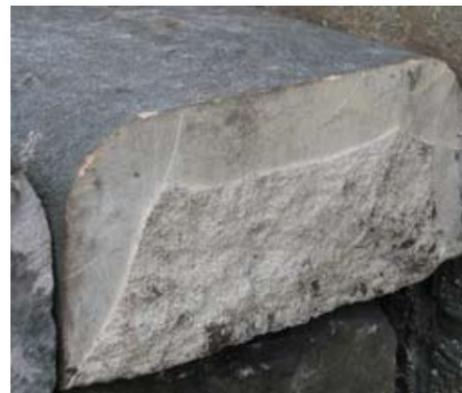
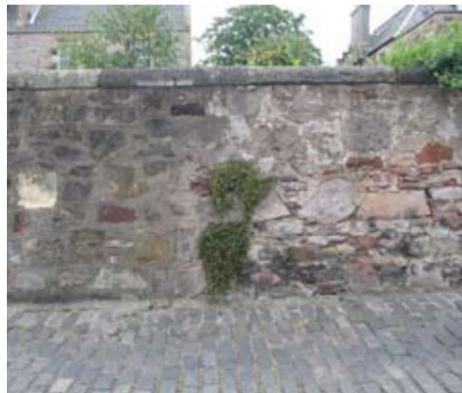
The modern technique for adjusting boundary walls frequently involves using a mechanical saw to reduce the length of some cope stones. This can leave an unsatisfactory finish as the technique also involves physically breaking the stone along the weakened lines of the mechanical saw cuts. Where cope stones require to be shortened the cut end of the stone should be carefully hand worked to match the original masons tooling.

It has also become commonplace to rebuild masonry walls in a style that does not reflect how they were originally constructed. Although the stones may be re-used in the rebuild, through lack of recognition that the stones were originally laid in horizontal courses, they now tend to be somewhat thrown together in a haphazard manner. This not only changes the appearance of the wall, it also creates a build that less strength than the original construction.

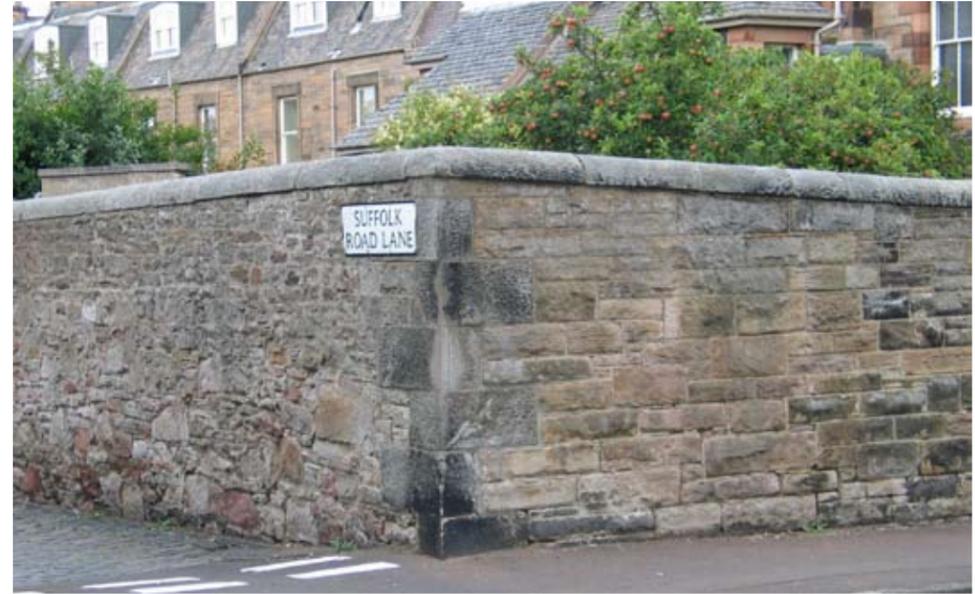
Coping stones

Due to the slenderness of the wall, the secret of their continuing stability lies in the provision of adequately dimensioned coping stones. Tooled by the mason to different profiles, including half-round, rectangular, chamfered and pyramidal, the cope stone bridged the thickness of the wall to shed rainwater over the wall face, especially if the

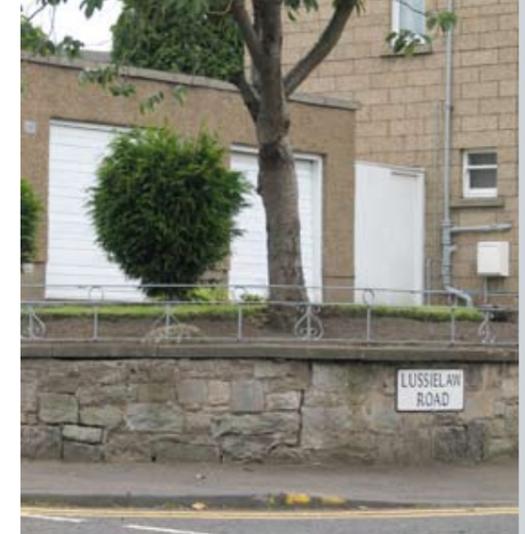
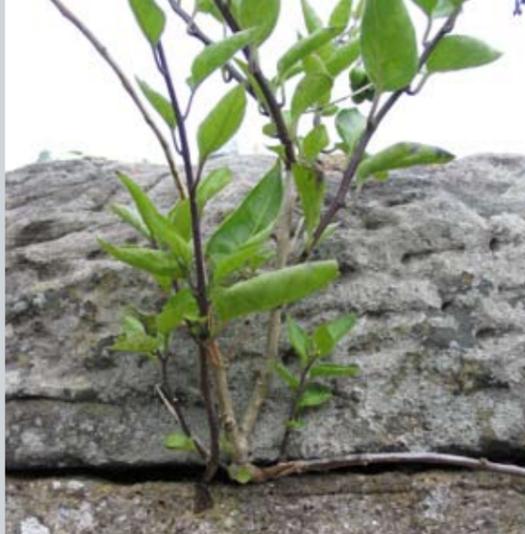
Growth

Where a wall has not been maintained, and the pointing material has become loose or dislodged, the ideal situation for the establishment of damaging plant growth has been created. Vegetation is often found growing out of the face of walls where the joints are open and this can lead to more damaging root penetration into the wall core. If this occurs below the cope the development of the roots can lever the cope stone out of place, and disrupt the pointing between the individual stones. This, in turn, can allow water to penetrate the core, nourish the roots and lead to further deterioration through encouraging the growth. Where vegetation has established itself on a boundary wall it should be quickly removed, and any open joints and beds repointed as soon as possible to prevent recolonisation. More established growths should be removed by hand weeding, ensuring that all the roots are also removed to avoid leaving potential paths for water ingress as they decay.

In situations where the growth has been left unattended for some time, and the root penetration is significant, the cope stones may

have to be up-lifted and small sections of the wall down-taken, to completely remove all the roots from the wall core prior to the wall being rebuilt. As far as possible the stones which have been removed should be replaced in their original position taking care to align with the original building courses.
