INFORM

INFORMATION FOR TRADITIONAL BUILDING OWNERS

Ventilation in traditional houses

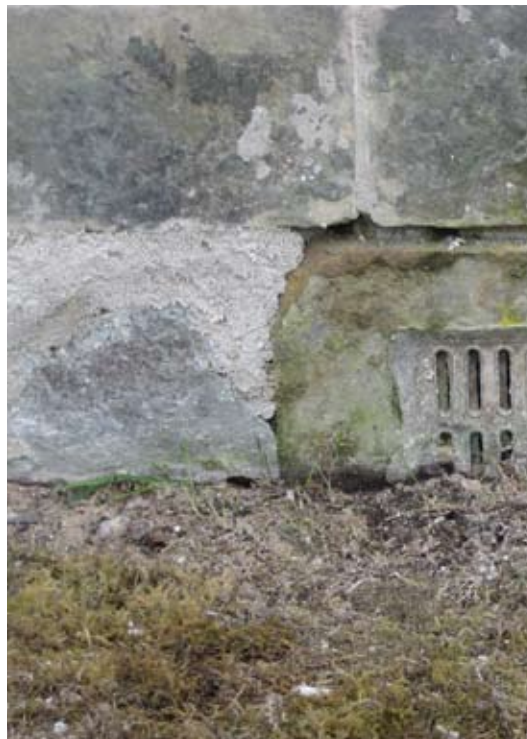
Despite recent masonry work to the elevation, this sub floor vent has

Many older buildings have timber floors on the ground floor, built on timber joists over the base of the house (often called the solum) with a void space between. The size of this space varies considerably, but normally joists sit at least a few inches off the ground or solum level. As this space is in close contact with the ground, a free moving air supply is required to ensure the humidity levels are kept low. This ventilation is normally achieved by iron grilles which are often set into the plinth or base course of the house. It is important that these air entry points are kept clear of any obstruction. In many repair projects, such important elements are neglected; rising ground levels, vegetation and even successive over-painting can obstruct these openings and lead to a lack of circulation, resulting in a build up of stagnant air.

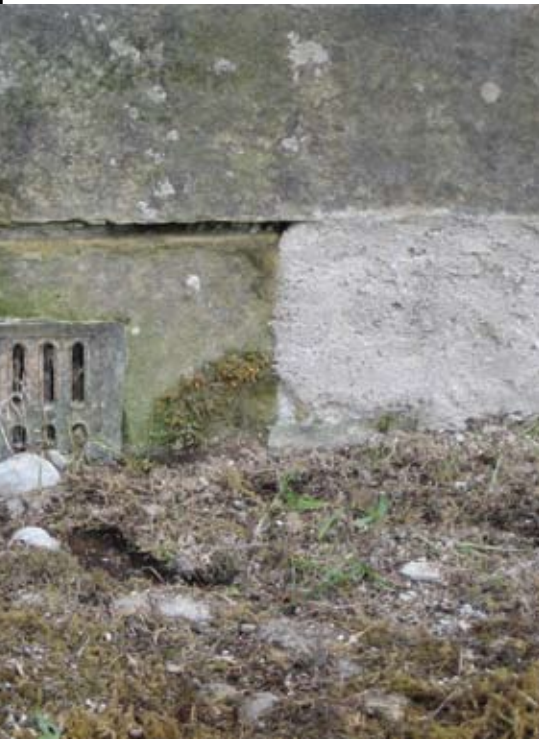
Grate blocked; note also the risen ground level.

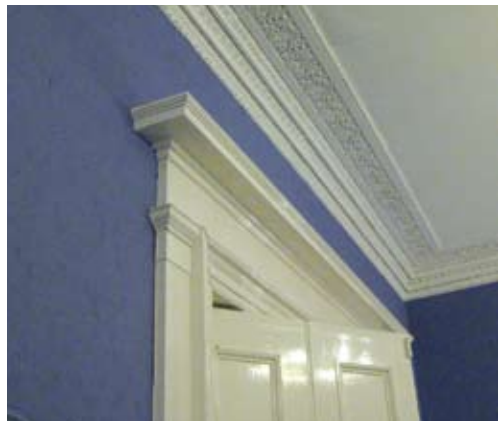
Hidden ventilation features in Randolph Crescent, Edinburgh – The pediment above the door admitted warmed air, and gaps in the cornice (now blocked) allowed it to be drawn away.

From the early 19th C many higher status structures were incorporating sophisticated passive air circulation techniques, mainly using the draw from hearths and flues (see cover illustration featuring a house in Randolph Crescent, Edinburgh, built in 1839) to allow warmed air to circulate through the building. Perforations in the cornice and door mouldings allowed warmed or “vitiated” air to be drawn up through the floors by the hearths above.

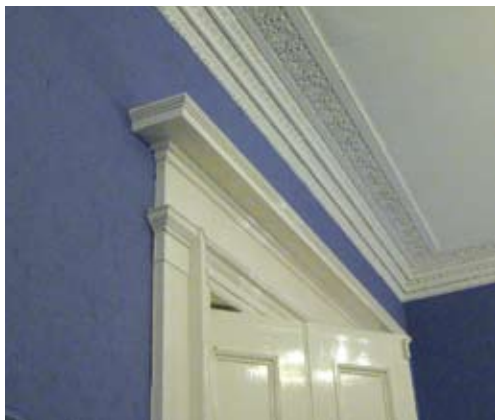
Hidden ventilation features in Randolph Crescent, Edinburgh – The pediment above the door admitted warmed air, and gaps in the cornice (now blocked) allowed it to be drawn away.

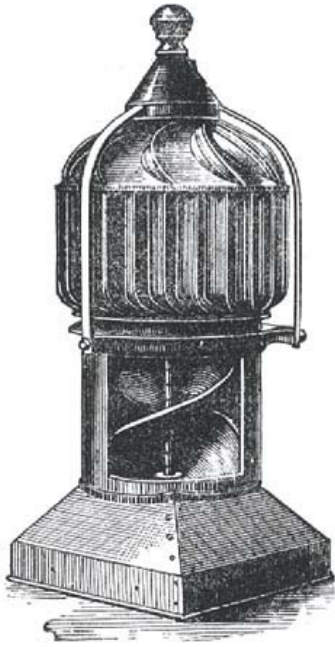
Patent ventilators from C1890.

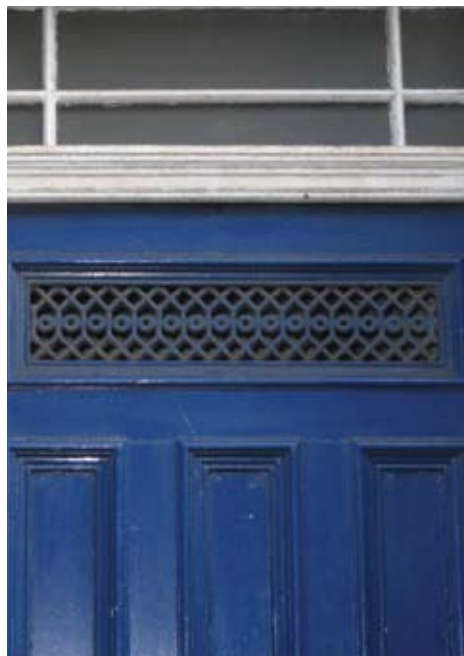
Ventilation grille in a late 19th C tenement door.

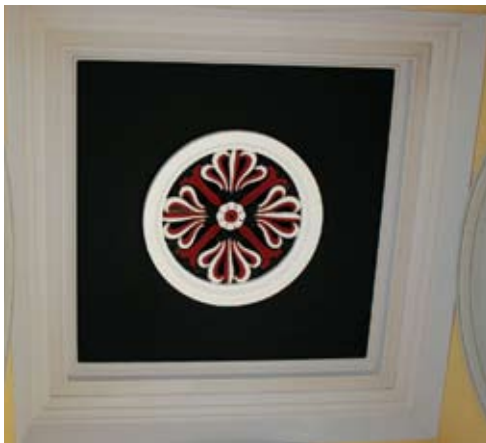
Closed up air vent in public building.

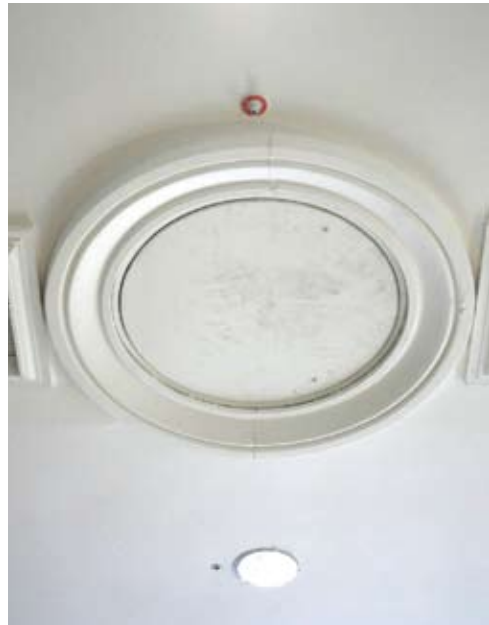
A decorative air vent at the top of 19th C stair.

In many older houses, tenements or flats, stairwells served as a ventilation pathway. Often at the top, opening onto the roof, were skylights and cupolas, sometimes with adjustable ventilation arrangements. This allowed what is called stack ventilation, whereby hot air rising up through the building was able to escape through the cupola or skylight opening. Cooler air was thus drawn in from other parts of the house, through windows or up through the floors and behind panelling. This natural ventilation feature is utilised extensively in modern low carbon buildings as an alternative to air conditioning or forced draught ventilation. Frequently during repair works these facilities are sealed or removed, causing moist air to accumulate; this moisture then condenses at night onto the glass and timber, causing progressive decay of the timber elements. Where possible such ventilation fittings
