INFORM

INFORMATION FOR TRADITIONAL BUILDING OWNERS

Rot in timber

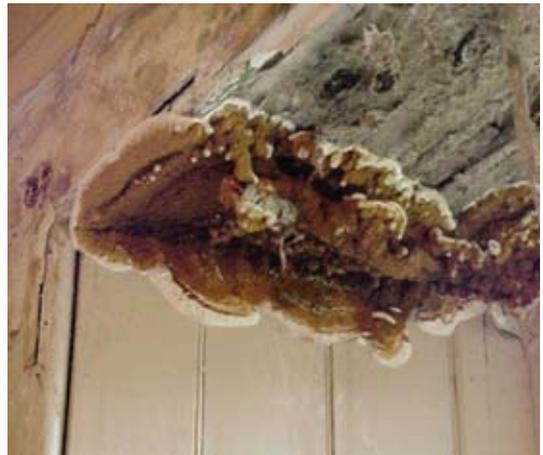
*The fruiting body of the dry rot fungus
City of Edinburgh Council*

Once a rot fungus is established in timber it can spread and grow throughout the wood as long as the conditions remain conducive. In suitably damp conditions dry rot can spread over inorganic substrates such as brick work and plaster to infect other timbers. It is important to note that when conditions change for example the moisture source is removed or the food source exhausted, rot will stop spreading and die off. The final stage of the spread of rot is when the fungus develops what is known as a fruit body which is a large fleshy body commonly bracket like in shape. This releases spores into the atmosphere to spread the rot further.

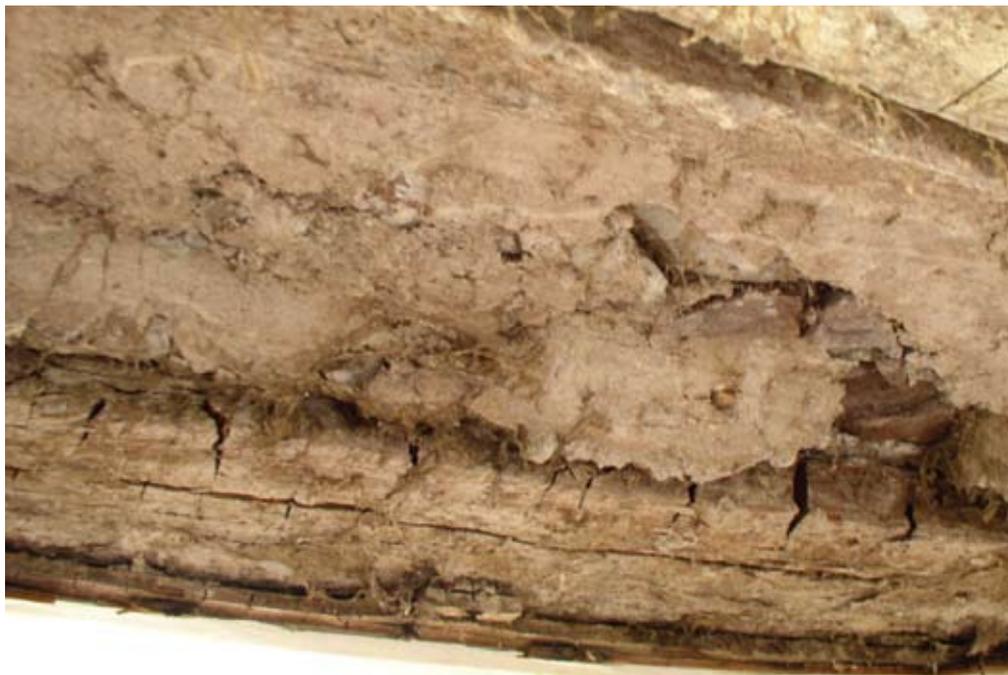
Cuboidal cracking caused by dry rot (City of Edinburgh Council)

Detecting dry rot in its early stages can be difficult. When it is taking hold dry rot appears white or greyish with the texture of cotton wool although can also appear yellowish or mauve in colour. As dry rot usually develops out of sight behind panelling or under floors it is unlikely it will be noticed at this stage. If wood appears soft to the touch or shrinkage is taking place this will likely be a sign of some form of timber decay occurring. A mushroom like odour may also be a sign of rot. When dry rot is fruiting (producing spores) a larger body known as a sporophore is created. This is circular or semi circular in form and is commonly reddish in colour with a white edge. Other signs of dry rot include a fine reddish dust on the surface of wood and cuboidal cracking light brown in colour.

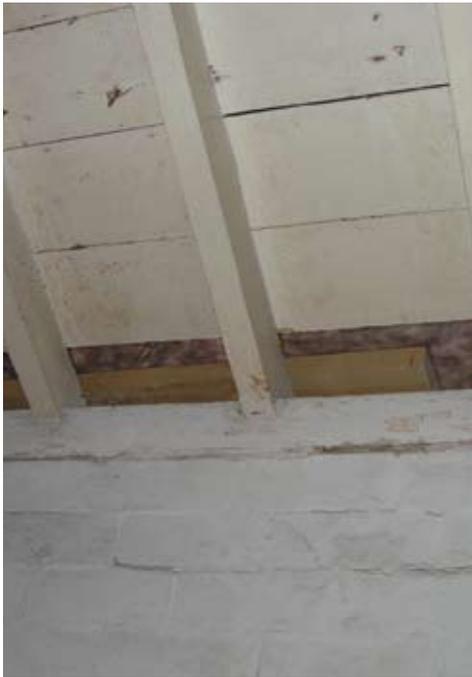
Brown discoloration showing the presence of wet rot

- Timber will feel spongy or soft to the touch
- Wood may be discoloured either darker or lighter depending on the type of rot present
- Skirtings or panels may become warped
- Paint can be lifted from the surface of wood if wet rot is present

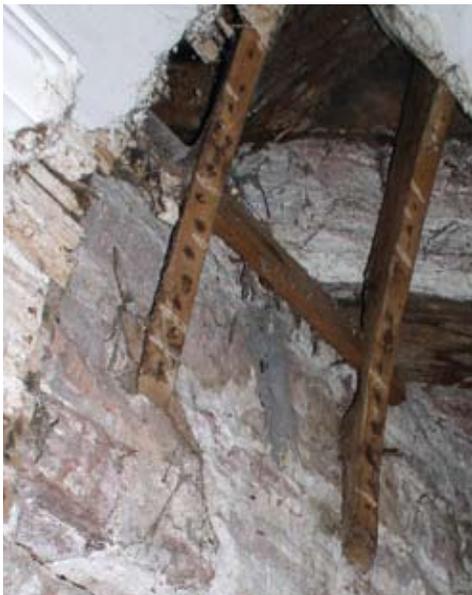
Exposed wall showing presence of dry rot

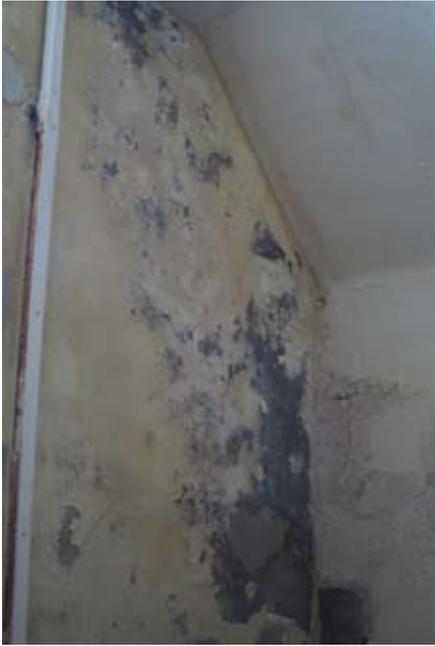
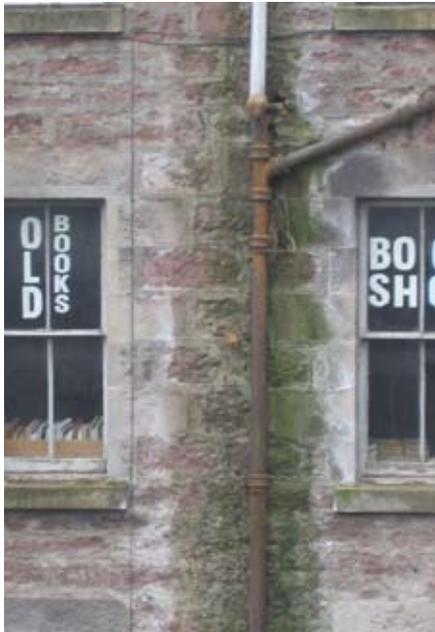
Defective rainwater goods can cause moisture ingress leading to damp conditions ideal for rot

- Defective plumbing
 - Blocked rainwater goods
 - Defective damp proof courses
 - Damage to roof structure
 - Masonry decay or damaged rendering
- Proper ventilation of areas susceptible to damp or moisture penetration such as cellars, solum (the area underneath a floor) or voids in walls.

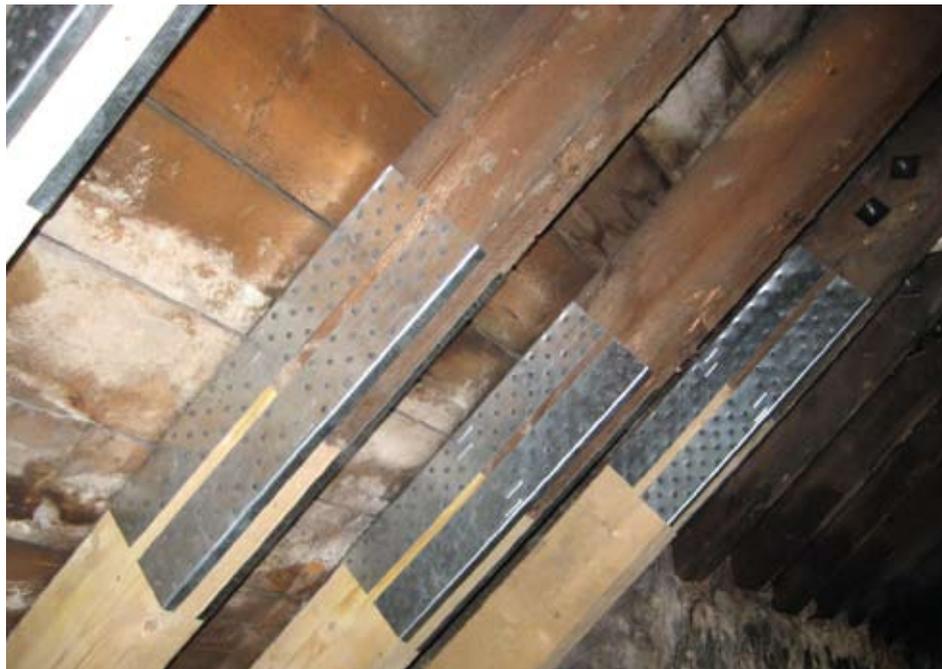
Timbers replaced following an outbreak of rot

Where rot has occurred it is important to remove any timber which has been affected. This will reduce the likelihood of the rot re-appearing and also re-instate the structural stability of a building which may have been compromised. Where the rot was in a relatively small area the wholesale removal of large areas of timber will not be necessary, for example where a floor board has suffered from attack, once the cause of the moisture is rectified there should not be any need to remove the floor boards adjacent unless they too show signs of rot.

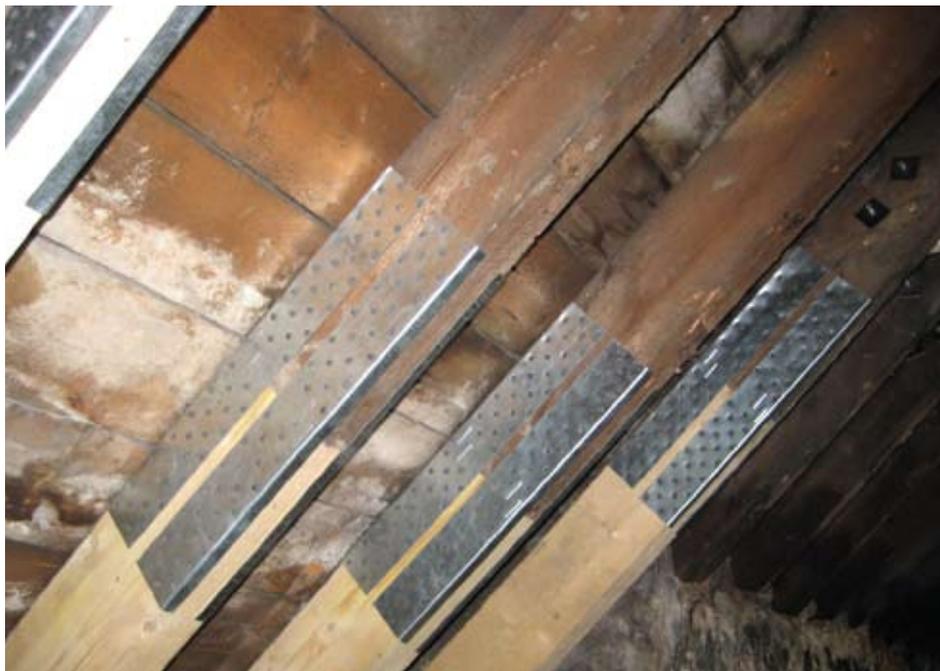
Timbers replaced following an outbreak of rot

Where rot has occurred it is important to remove any timber which has been affected. This will reduce the likelihood of the rot re-appearing and also re-instate the structural stability of a building which may have been compromised. Where the rot was in a relatively small area the wholesale removal of large areas of timber will not be necessary, for example where a floor board has suffered from attack, once the cause of the moisture is rectified there should not be any need to remove the floor boards adjacent unless they too show signs of rot.
